# M58 Link Road

## Ground Investigation Report

Wigan Council

July 2021  
Version C01

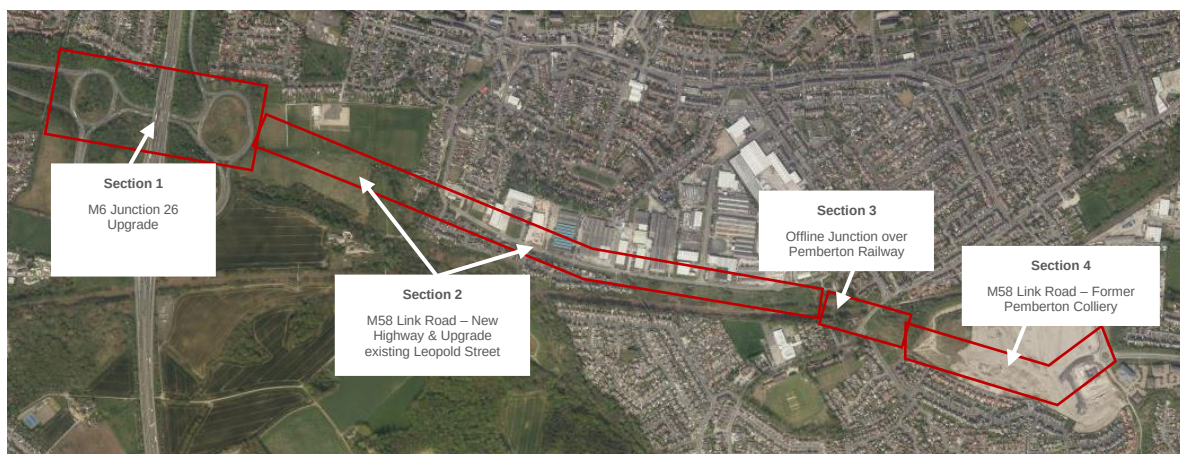
Figure 1-1 - Overview of scheme sections

The scheme comprises 4 sections, indicated in Figure 1-1 and shown in attached General Arrangement Drawings in Appendix G. This Ground Investigation Report covers sections 2 and 3 indicated in Figure 1-1. Section 1 containing the J26 motorway roundabouts will be investigated as part of the programme of drilling and grouting due to occur at a later date. Section 4 which crosses the former Pemberton Colliery has previously been remediated and a validation report for Phase 3 of the remediation works has been made available to Atkins. For Section 4 confirmatory chemical and in-situ testing is expected to be required during detailed design and/or construction which will be reported on separately.
