The Heaton Group

Ancillary Buildings, Eckersley Mills

Heritage Statement

04 September 2023

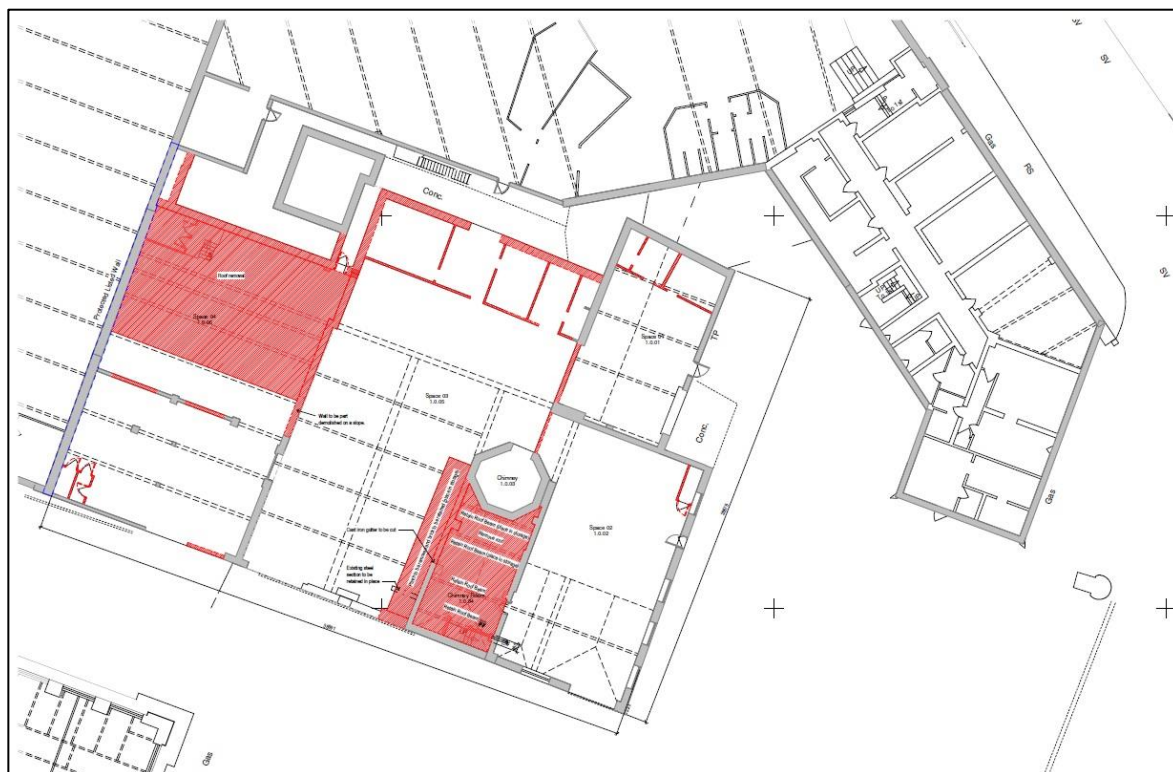
Image 9.1: Completed demolition works (removed fabric identified in red)

- 9.5 Image 9.1 also illustrates which walls are to be retained on a temporary basis (identified in grey), along with some areas of historic roof, and the chimney and chimney base. Despite the approval of applications for the comprehensive demolition of buildings within the

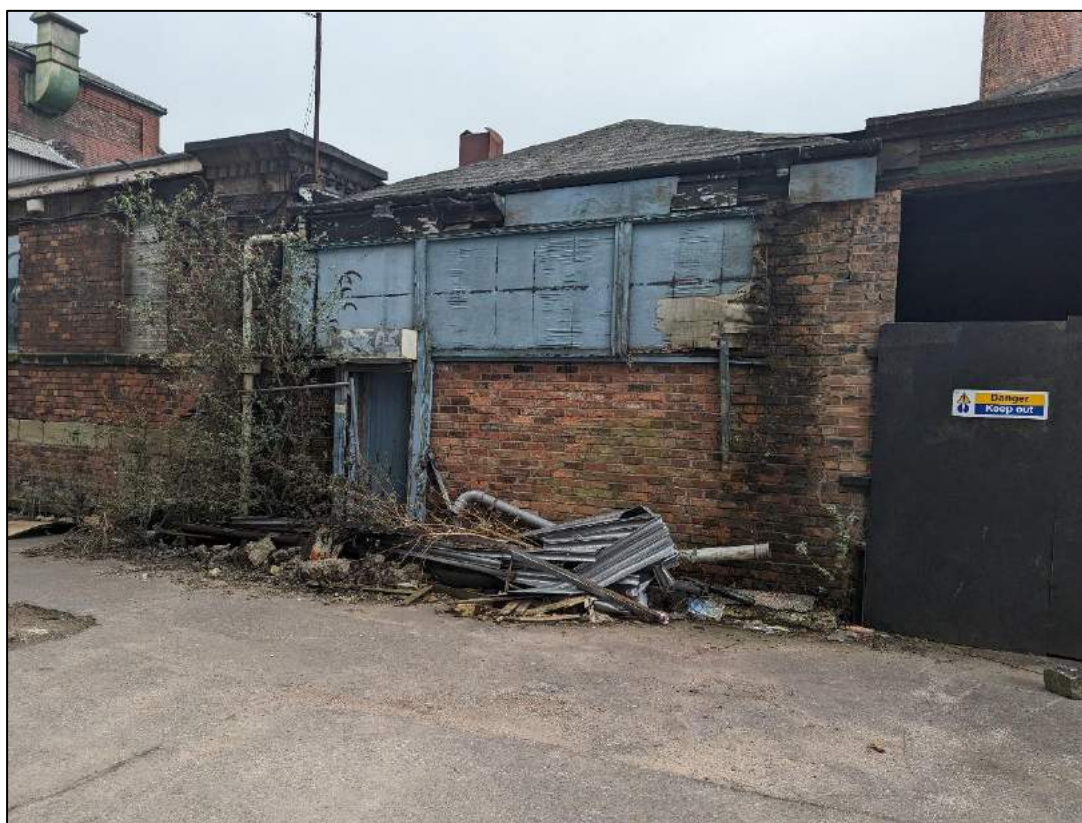
Plate 1: Western end of south elevation

- 6.7 (Plates 1 - 6). This faces onto Mill 1. At the western end it is connected to the old reeling room, and forms a continuous face in English Garden Wall bond (4:1). However, this is soon interrupted by an inserted personnel doorway to bays 1 and 2, with timber cladding over and across the whole of the top of the face of both. To the west of the doorway the wall has been rebuilt in a lighter brick in stretcher bond to bay 2 but is otherwise featureless. Bay 3 lies to the east and has a large loading doorway inserted into the rebuilt wall, with rough joints visible. This reaches the full height of the elevation and the charred timber lintel is visible across bays 3 and 4. Bay 4 is again rebuilt in brick but appears to be more modern than the rebuilt section to the west. This contains a timber framed window, partially covered by timber over the top half of the face.

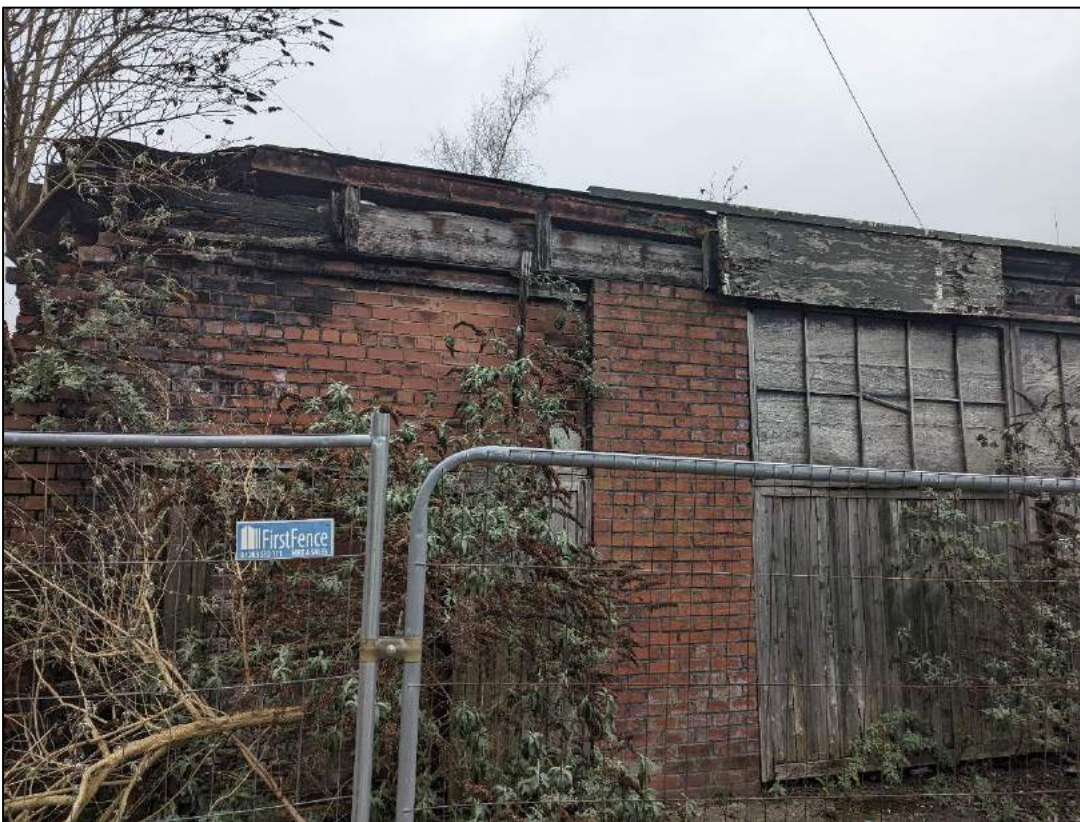
Plate 8: West end of 5 bay south elevation

- 6.8 To the east the face has completely collapsed (plate 7), leaving an overgrown opening to the central room of the complex. East of this the face continues (plates 8 - 11) as a five bay elevation. At the western end the face is red brick in English Garden Wall bond (3:1) with a timber shutter in front. To the east the face steps forward slightly and is constructed in a duller brick in English Bond. Beyond this the face is covered in timber to all bays. At the far western end bay 5 is open, presenting as a large loading doorway. The modern brick jamb visible to the west shows this opening to have been a later insertion.

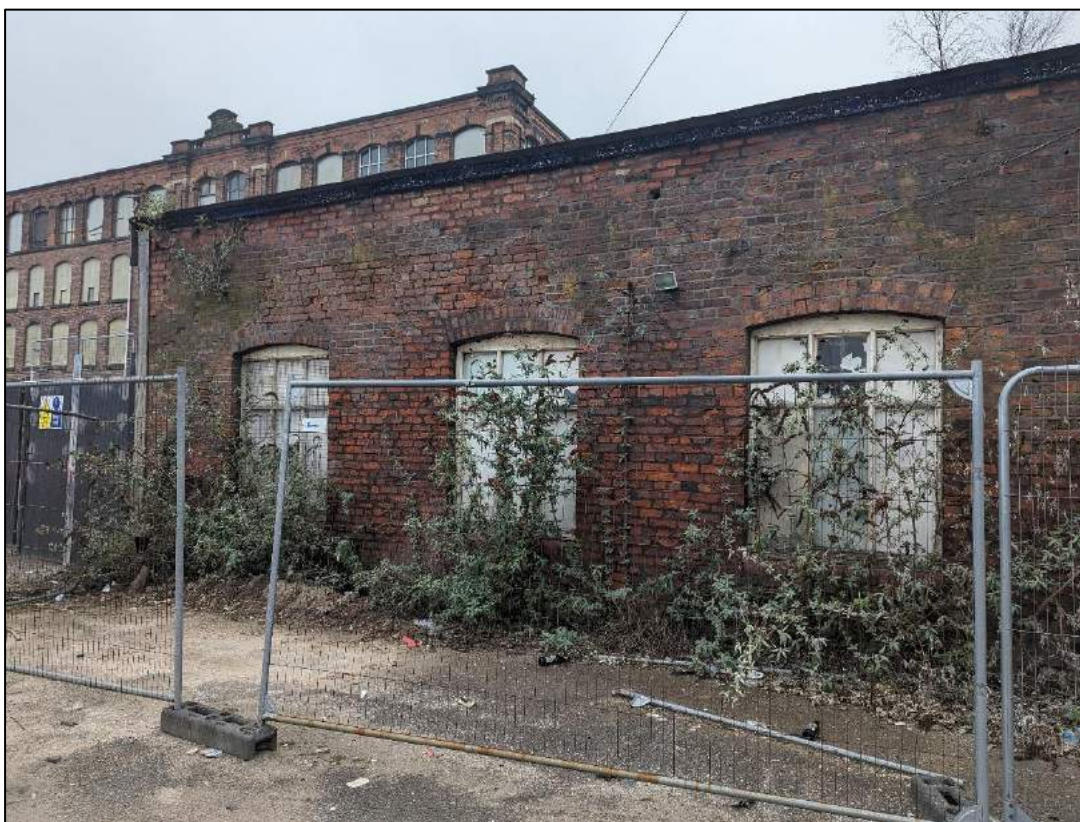
Plate 12: Southern end of east elevation

- 6.9 At the southern end of the face (plates 12 - 14) is a 5 bay section set forward from the rest of the face. Bays 1 to 3 each contain a large portrait window with timber frame of 9 lights and a depressed arch lintel of bricks. The face is constructed in a dark red brick in English Garden Wall bond (4:1). In bay 4 the window has been blocked and a personnel doorway inserted. To bay 5 the window has been completely removed and the wall rebuilt. To the north of these the face is set back and is of 4 bays (plates 15 - 19). Bay 1 contains a large inserted loading doorway, with modern metal shutter door hung. Bays 2 to 4 each contain a blocked opening. That to bay 2 has had a personnel doorway inserted.

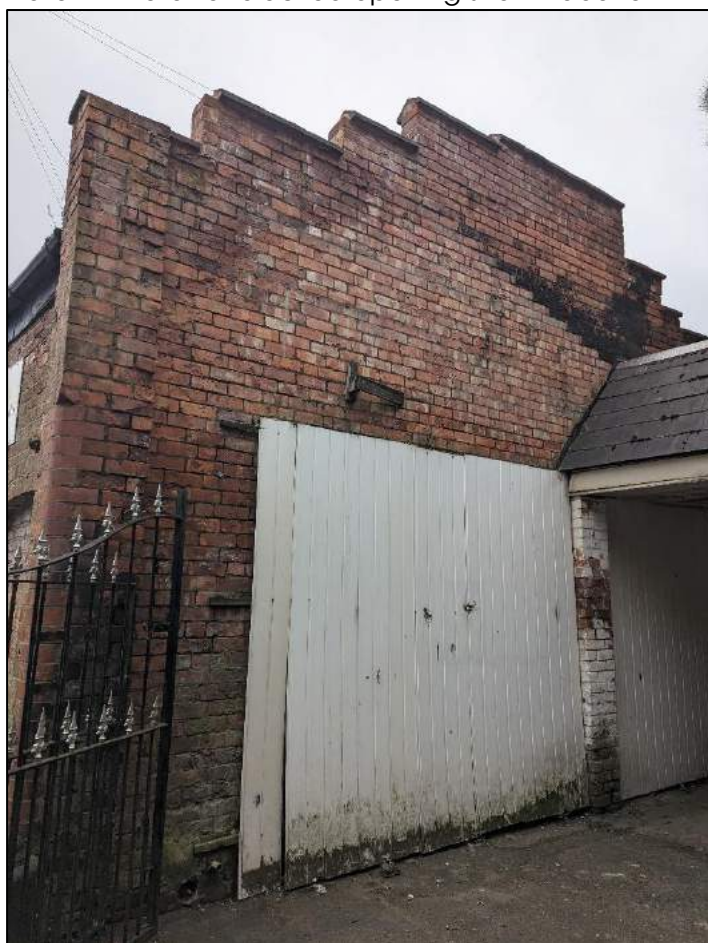
Plate 20: East end of north elevation

- 6.10 At the eastern end the face is of 2 bays, with much of the face covered in timber boarding (plate 20), suggestive of large blocked openings. The ghost of a former pitched roof is visible to bay 1, whereas a modern roof butts against bay 2, between the boiler house and the office block to the north. To the west the face is set back, forming a narrow walkway between the building and the office block to the north (plates 21 – 25). At the eastern end however, the wall has collapsed, standing only c. 1m high. To the west it remains its full height however and shows the English Garden Wall bond (3:1). This stops at a rough joint where the wall has been rebuilt and a personnel doorway inserted, with concrete lintel over. The western jamb, however, shows the original wall continuing westward. This appears to have again collapsed at some point, with a rebuilt section present at the far western end. This rebuild continues around the corner, forming the western elevation (plate 26). To the west the face is set back once again and lies behind the standing chimney (plates 27 – 30). At the western end a personnel doorway is present, within the wall, which itself is a continuation of the rebuild. West of this the face is older brick in English Garden Wall bond (4:1) with a wide opening inserted. This has a decorative iron lintel over and has been blocked with modern brick with a personnel doorway to the east side. A crack runs up the face to the east of this doorway and plants are coming through the brickwork.

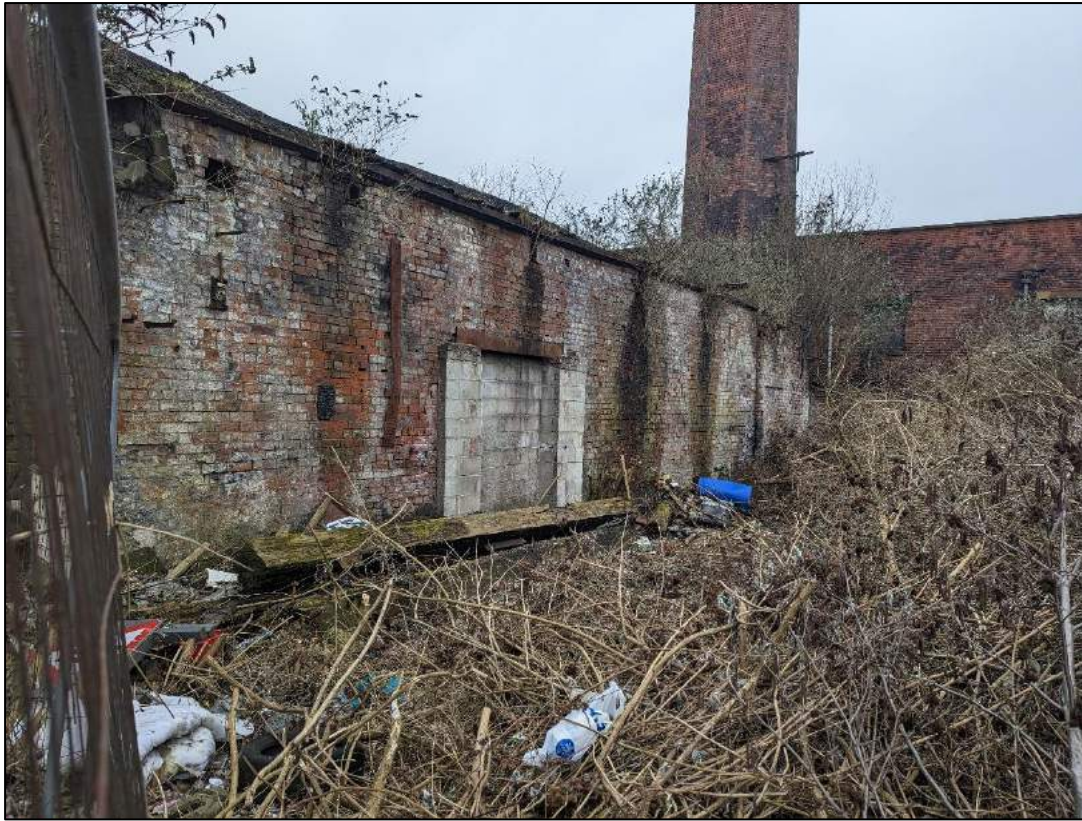
Plate 31: Central room showing western wall

- 6.11 The western unit was inaccessible. The central unit (plates 31 – 41) was accessible as the front (south elevation) of the unit had collapsed. This was heavily overgrown and strewn with debris from the collapsed roof. Along the western wall a loading doorway was present towards the southern end. This was blocked with concrete block and had projecting concrete block jambs. The wall itself was constructed in English Garden Wall bond (3:1). A blocked transmission window was visible high in the face to the north of the loading door. Traces of whitewash were present throughout. To the east side of the space was the base of the octagonal chimney and within the attached wall to the south a part of the flue system was visible. To the west of this wall a brick built plinth was present, running parallel to it and curving around the chimney at its northern end, before being broken. In the northern face of the chimney base is an opening, with charred timber surround present (plate 41). To the

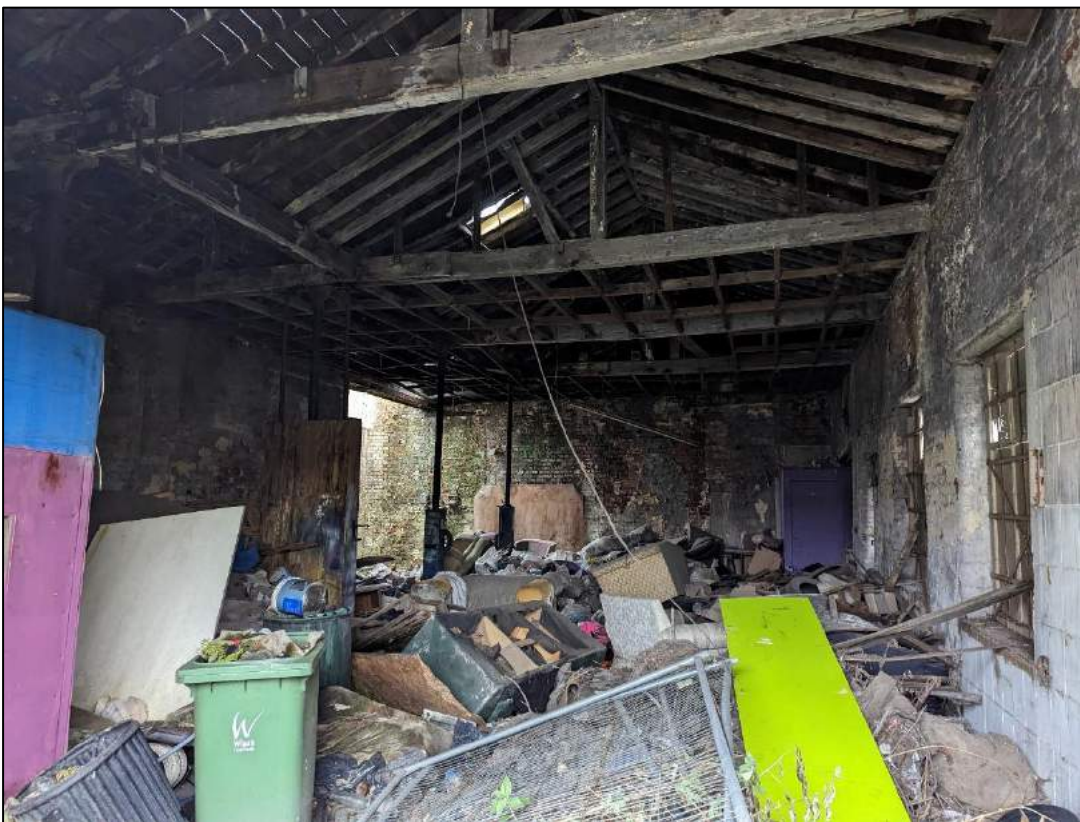
Plate 42: Interior of southern room to eastern side

6.12 The eastern unit comprises two separate areas, one to the north and one to the south. The southern (plates 42 – 46) was accessed via the south elevation and comprises a single open space. The roof was still present in this area, showing the four king post trusses. The area was strewn with debris and was unsafe to enter. The walls were bare brick although traces of plaster were present. In the north wall a straight joint runs up the face, showing the western side to have been rebuilt. At the north end of the west wall was a wide opening. This was blocked and seen from the central unit.

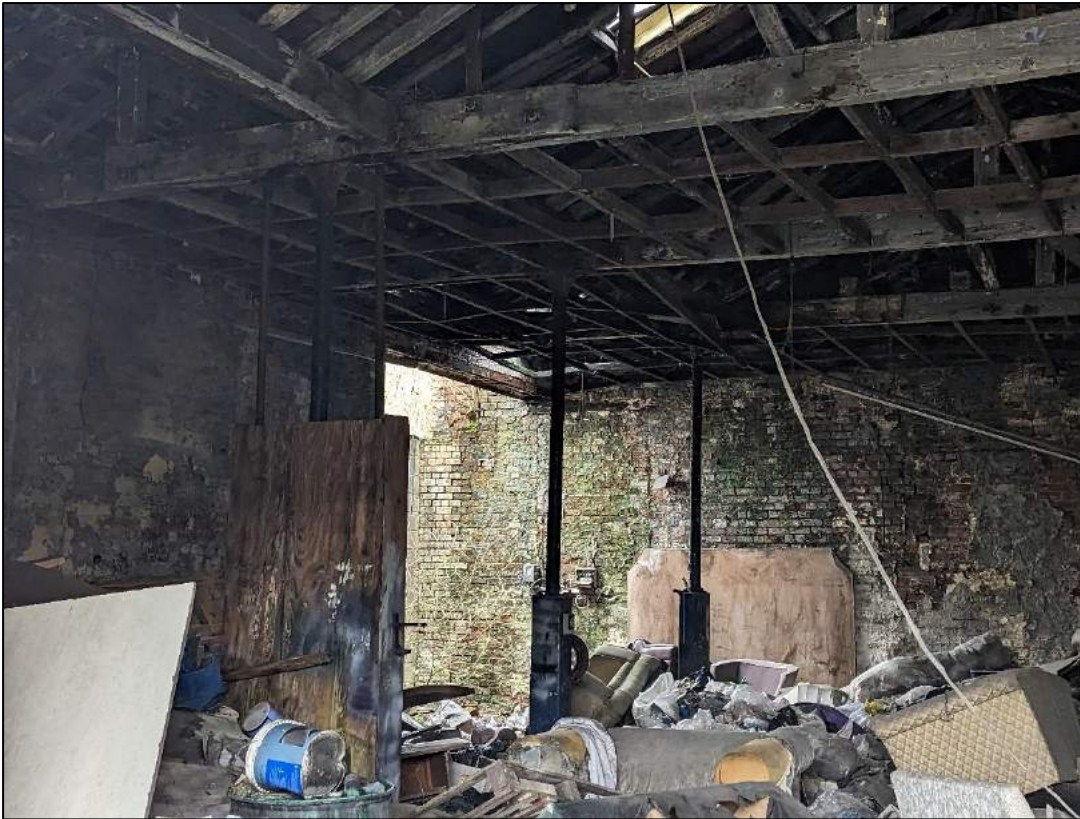
Plate 45: Opening at north end of west wall

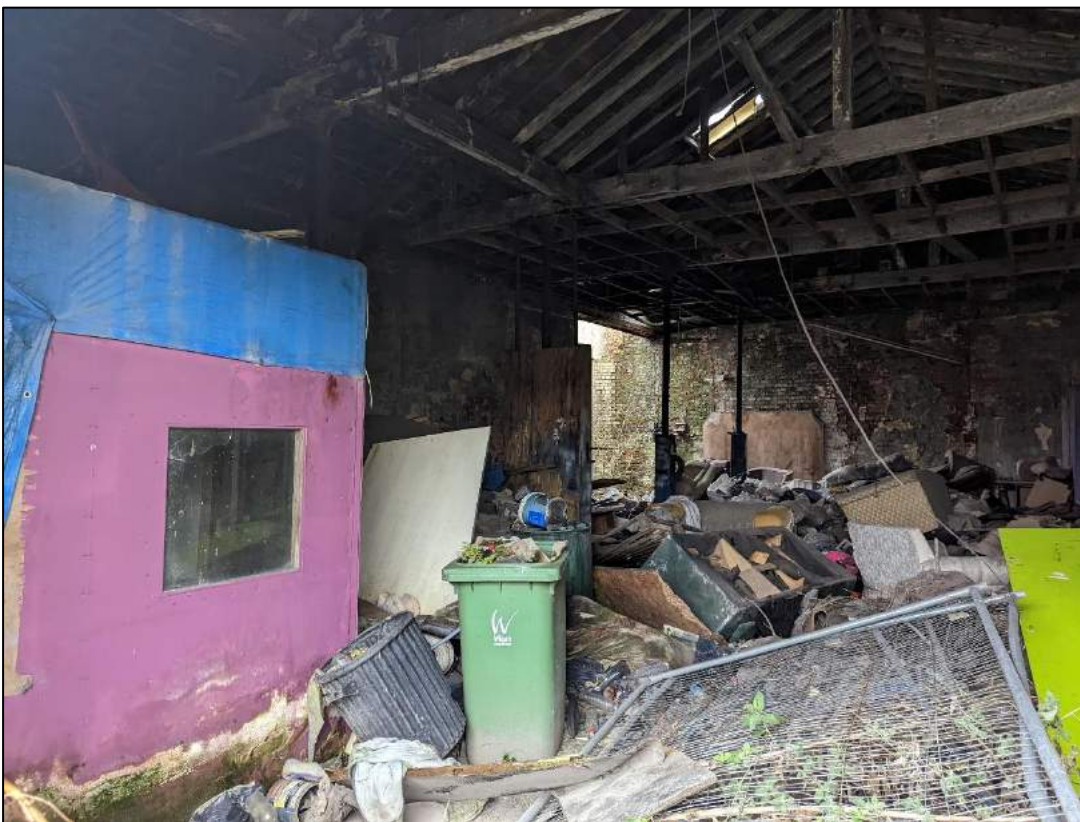
Plate 46: Western wall

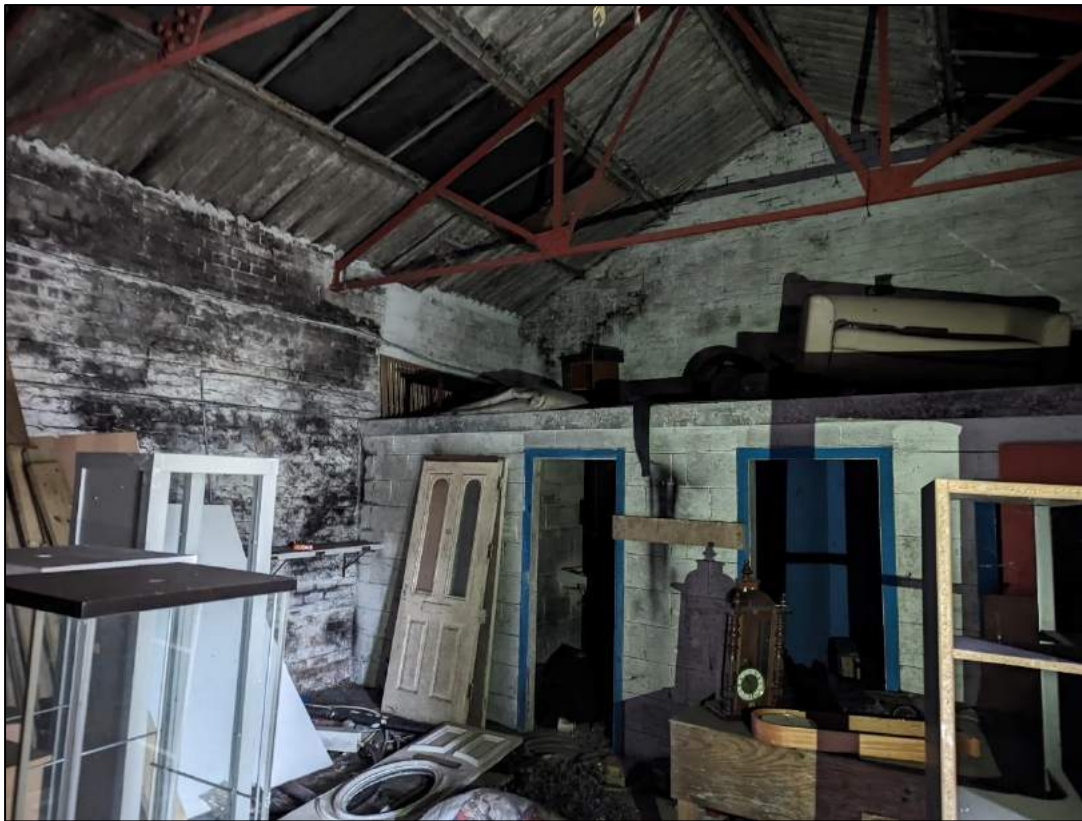
Plate 47: Northern room to eastern side showing modern inserted wall to the north

6.13 The north-eastern unit (plates 47 – 51) was accessed via the loading and personnel doorways inserted in the east elevation. These also lead into a single open space. The southern wall forms the party wall between the two units and contains a pair of large recessed openings with RSJ lintels over. The whole is covered with whitewash, making it difficult to tell if they were built as recessed or are blocked openings. At the southern end of the west wall is a blocked loading doorway to the central unit, with RSJ lintel over. At the northern end of the room a series of three rooms have been formed from modern concrete block. The roof is corrugated asbestos sheets supported on cast iron trusses.

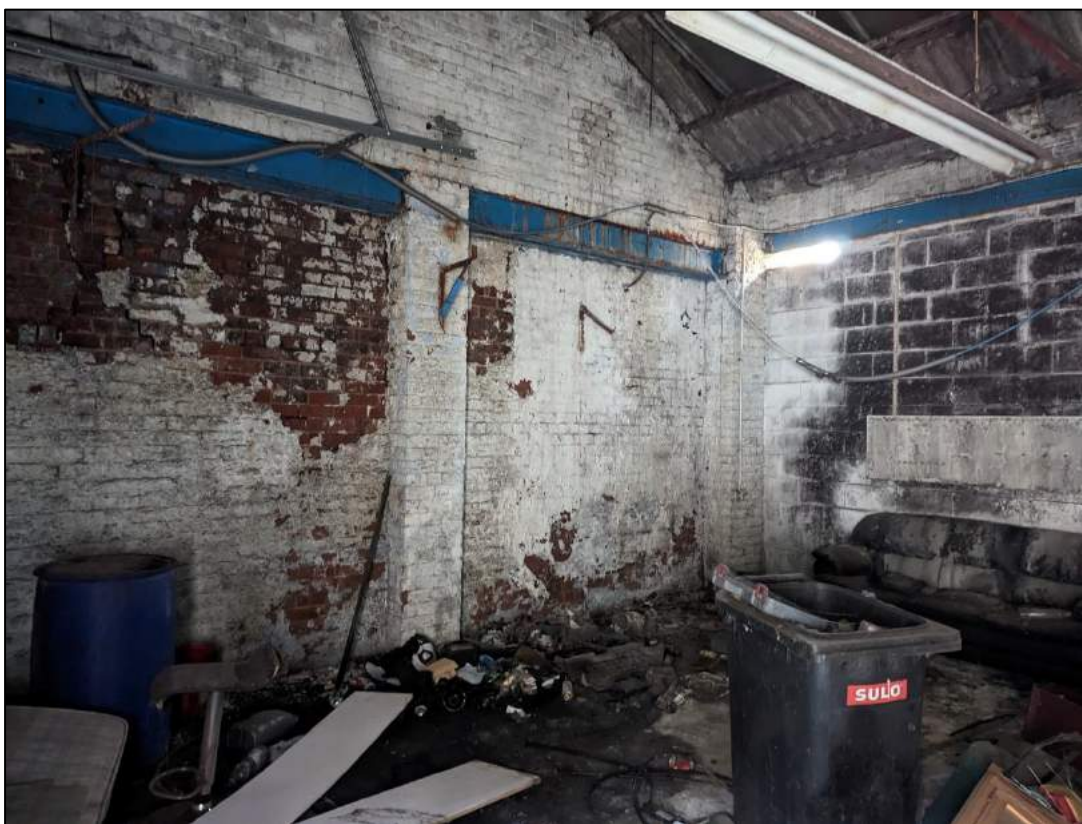
Plate 48: Blocked openings in south wall

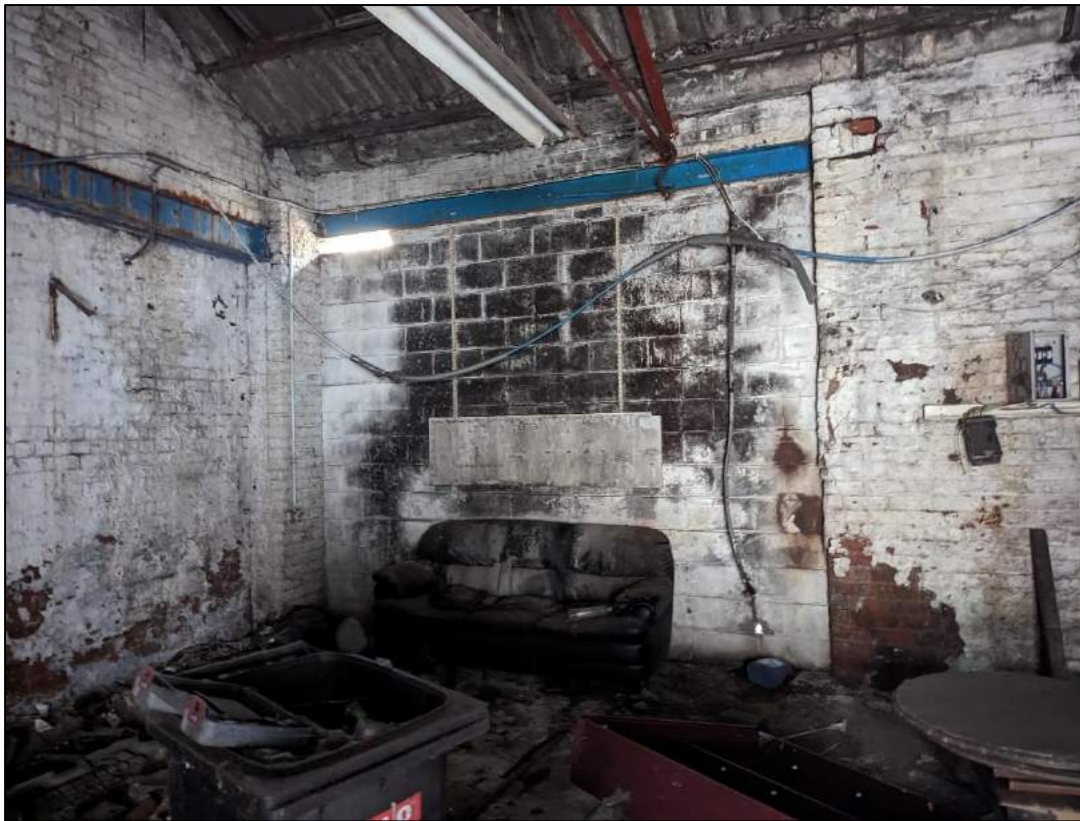
Plate 49: Blocked loading doorway in south end of west wall

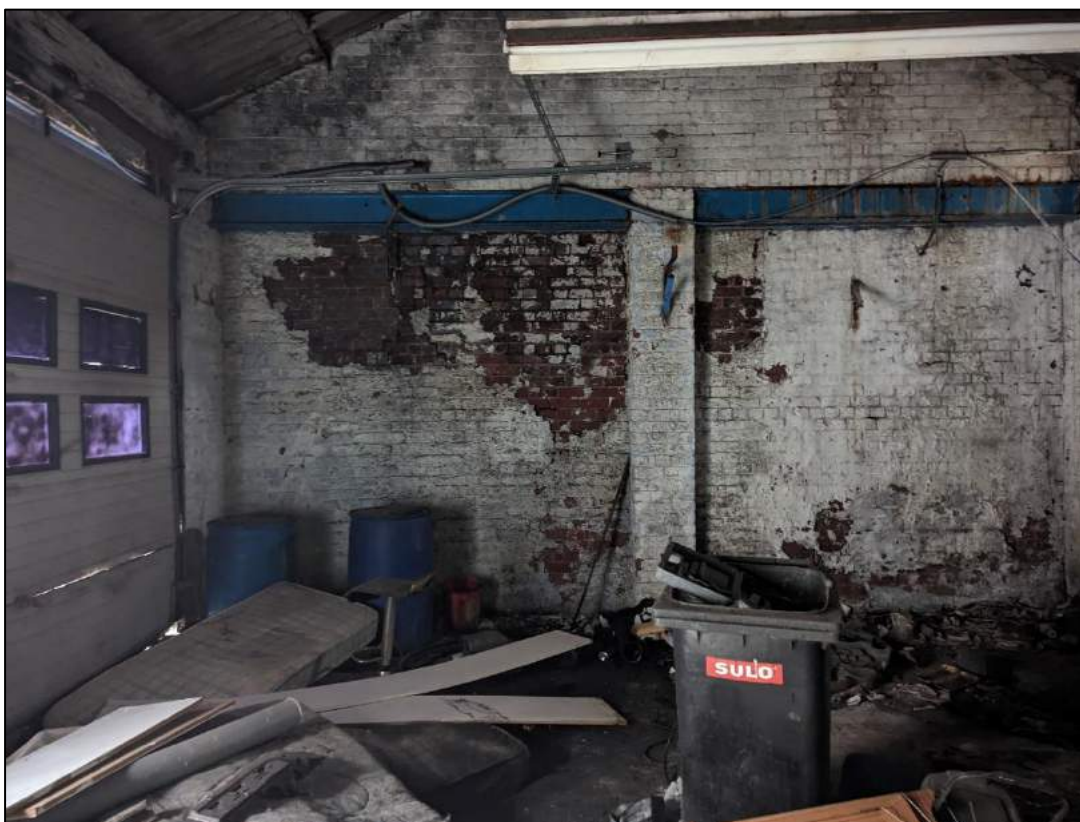
Plate 50: South wall showing blocked openings

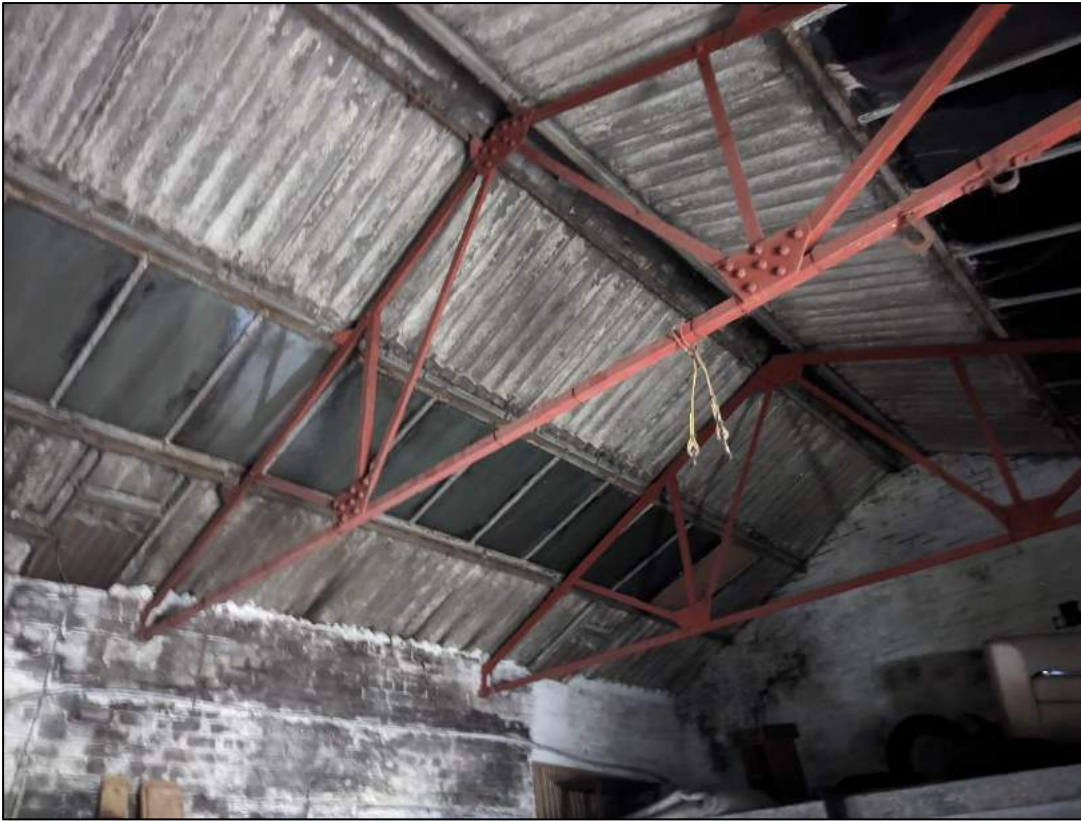
Plate 51: Truss detail
